A Study of Low Touchdown Improvement in Perpendicular Disk Drives

A THESIS SUBMITTED IN PARTIAL FULFILLMENT
OF THE REQUIREMENT FOR THE DEGREE OF
MASTER OF ENGINEERING IN DATA STORAGE TECHNOLOGY AND
INNOVATIONS (INTERNATIONAL PROGRAM)
INTERNATIONAL COLLEGE
KING MONGKUT'S INSTITUTE OF TECHNOLOGY LADKRABANG
2013
KMITL-2013-IC-M-005-010

Thesis Title A Study of Low Touchdown Improvement in Perpendicular
Disk Drives

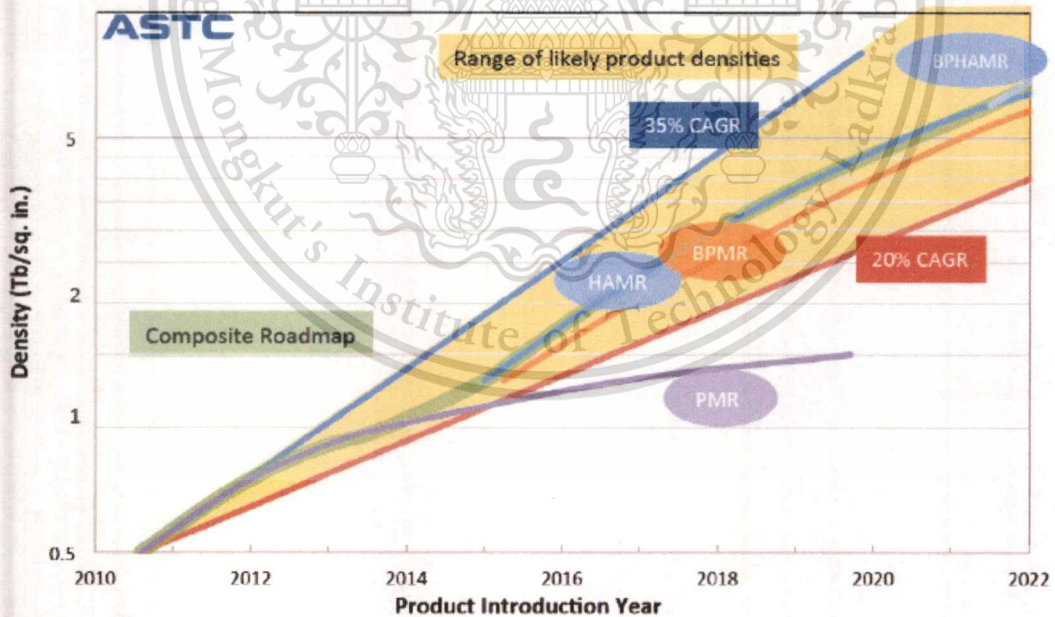
Fig. 1.1 Areal density timeline [2].

The HDD industry is expected to manufacture 2Tbit/in² technology products sometime between 2012 and 2016 as shown in Figure 1.1. In 2015, the HAMR (Heat Assisted Magnetic Recording) or the BPMP (Bit Patterned Media Recording) will be the candidates to achieve the areal density 2Tbit/in² or above. The pattern media is the next generation after HAMR to get more areal density, however, BPMP requires a number of technical changes, such as head design, signal processing, and write timing [2].

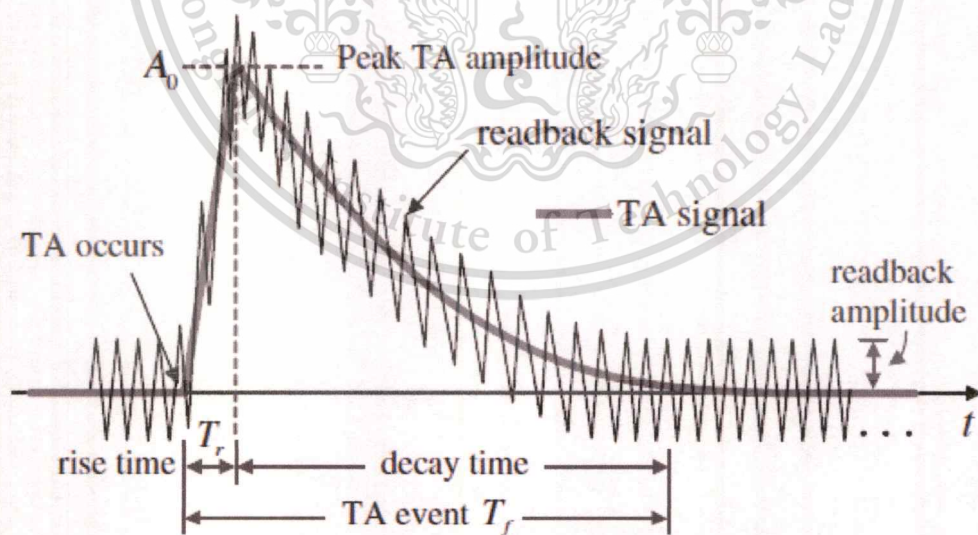
Fig. 2.7 TA model [7].

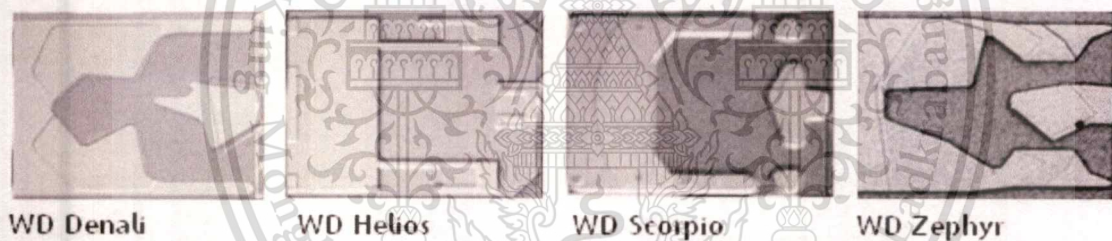
Fig. 3.6 Examples of competitive air bearing surface (ABS).

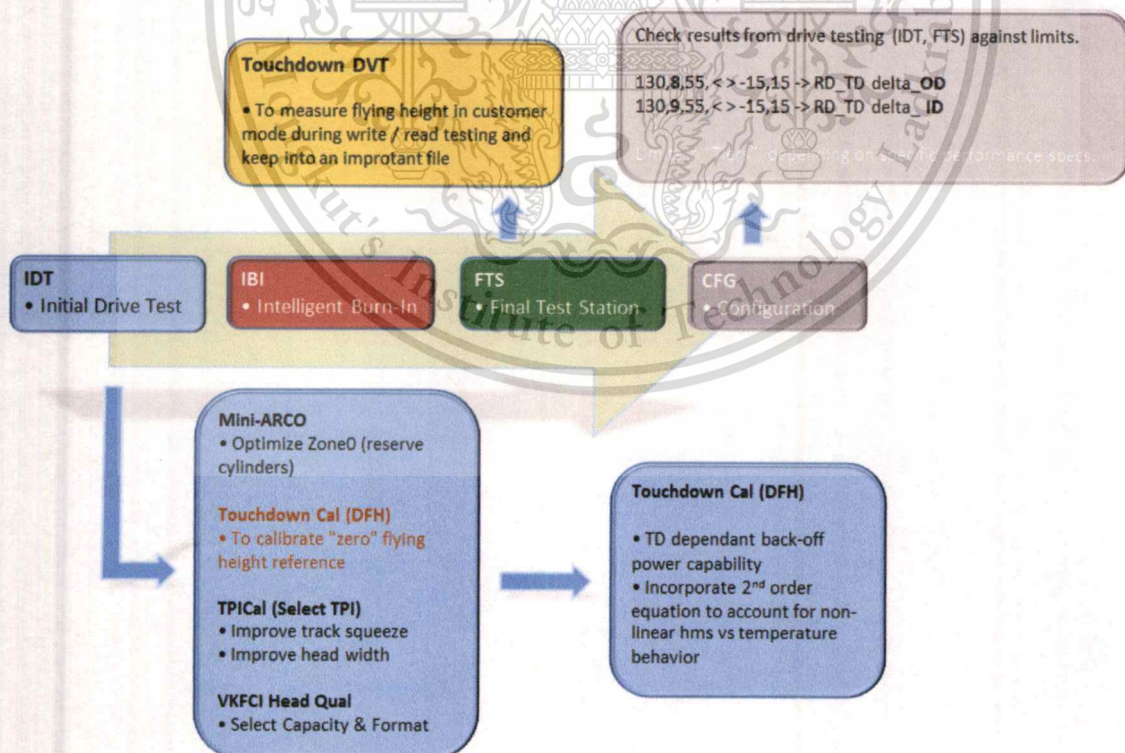
Fig. 3.8 HDD test operations.

Figure 3.8 shows the overview of the HDD test process. After assembling, the drive is transferred from the cleanroom and goes through printed circuit board assembly before starting test drive performance in the tester.

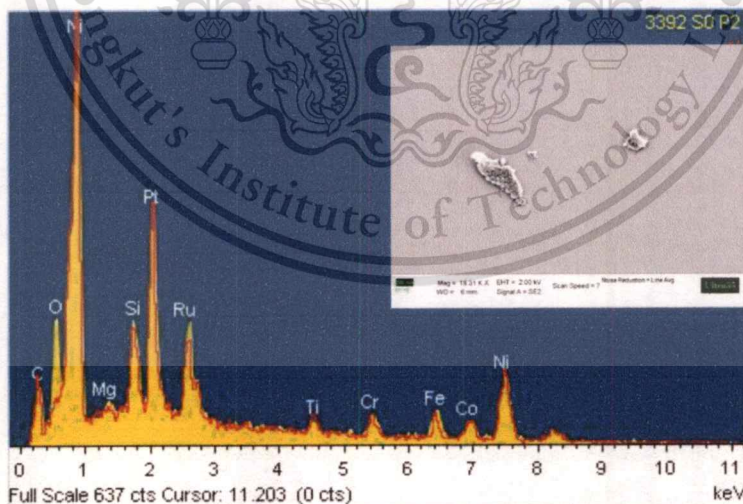
Fig. 3.14 The scanning electron microscope (SEM) image of drive SN#2.

Figure 3.14 shows tear down analysis result of the drives SN#2. According to figure 3.13, head0 is abnormal. The contamination lab shows contamination of moderate C-O flake found at the extreme OD of the media surface. The top surface looks normal and has no abnormality.

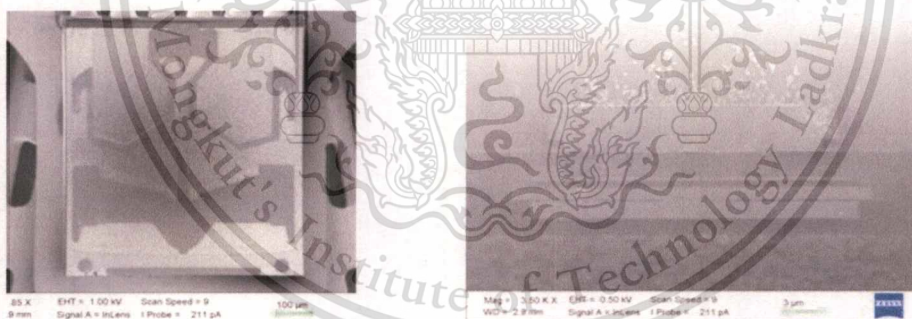
Fig. 3.16 Picture from the scanning electron microscope (SEM).

Figure 3.16 shows the tear down analysis of the drive SN#6. From SEM picture, we can see the contamination Diamond-Like Carbon (DLC) wearing on the head pole tip. This is the root cause TD power decrease. The TD profile of the remaining heads looks normal.

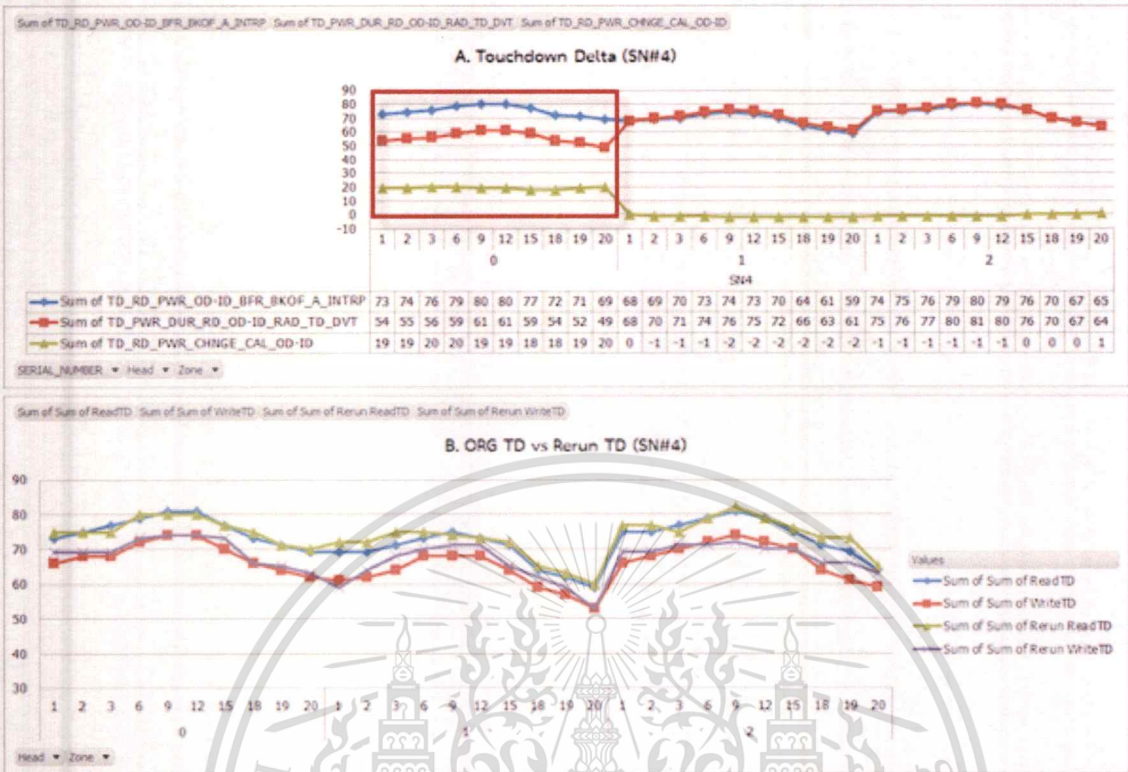
Fig. 3.17 Comparison of TD delta between the original TD and rerun TD of HDD SN#4.

Figure 3.17 shows the result after rerun. The drive can duplicate TD failure. We use the oscilloscope to measure the signal. Figure 3.18 shows the scope picture of drive SN#4. The waveform received from the abnormal head (head0). We can see that the waveform looks abnormal. We zoom-in on that location and observe asymmetry signal. Normally, it is supposed to be flat across all the waveform. Therefore, we suspect that the head may be degraded during the test process. The abnormal drive will be sent to the HSA supplier for investigating the root cause which can be either the head stack process or the drive process related.

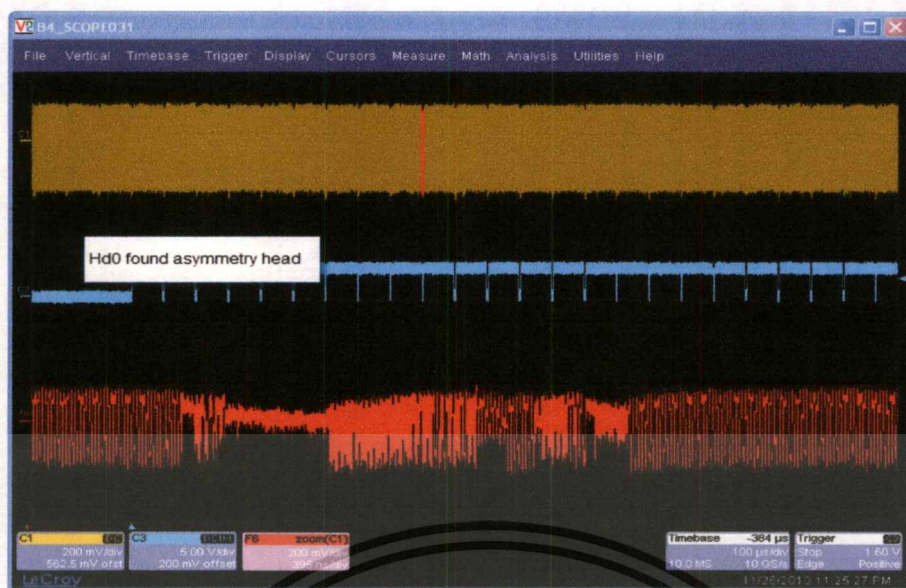
Fig. 3.18 Asymmetry signal on head0.

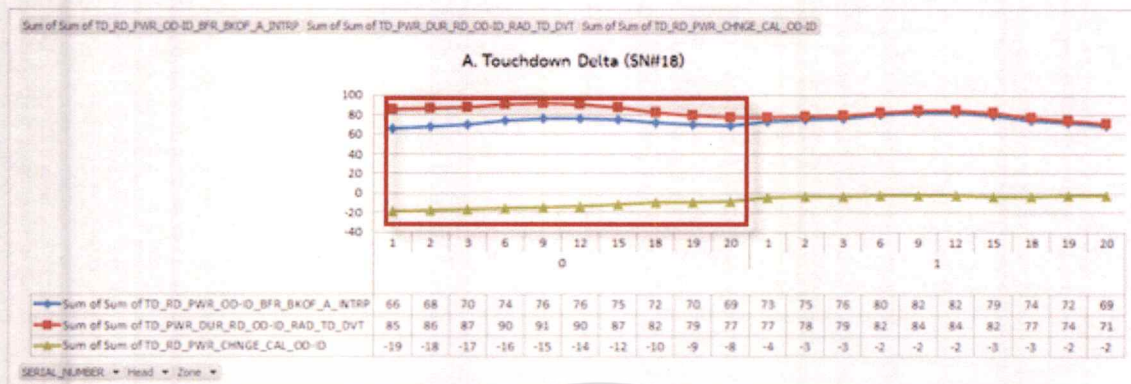
Fig. 3.26 Comparison of TD delta between the original TD and rerun TD of HDD SN#18.

Figure 3.26 shows one more example of TD failure. The TDP between post-test and pre-test $\pm 15\text{mW}$ on head0.

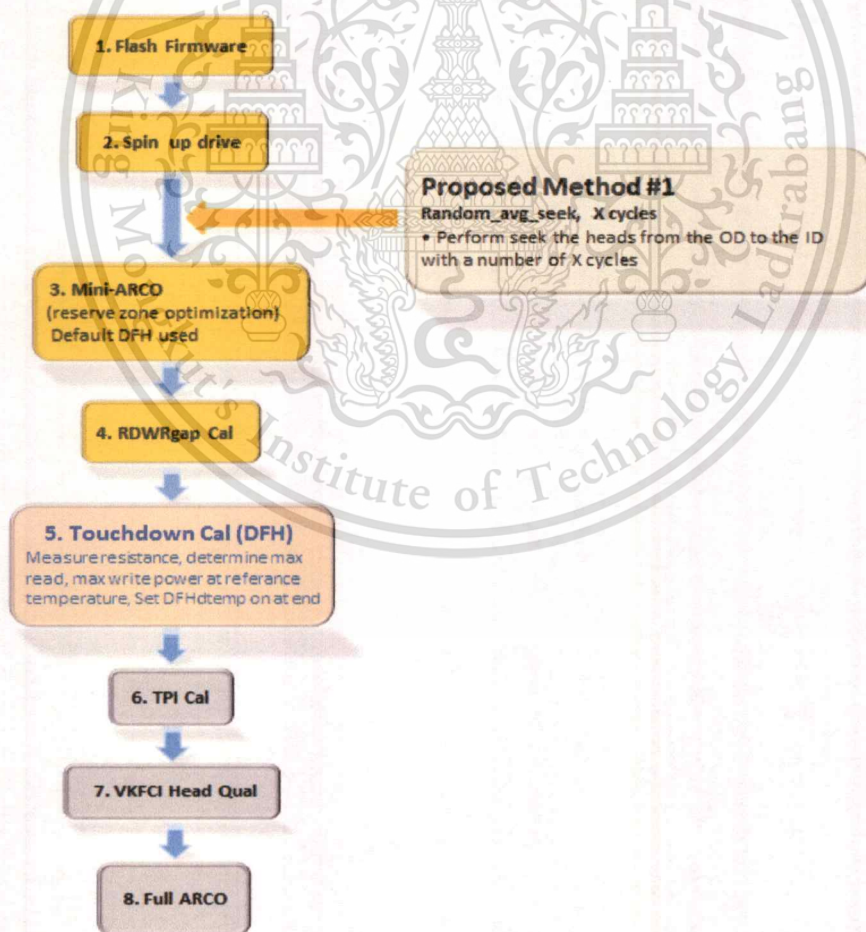
Fig. 4.1 The test sequence and additional step of the first proposed method.

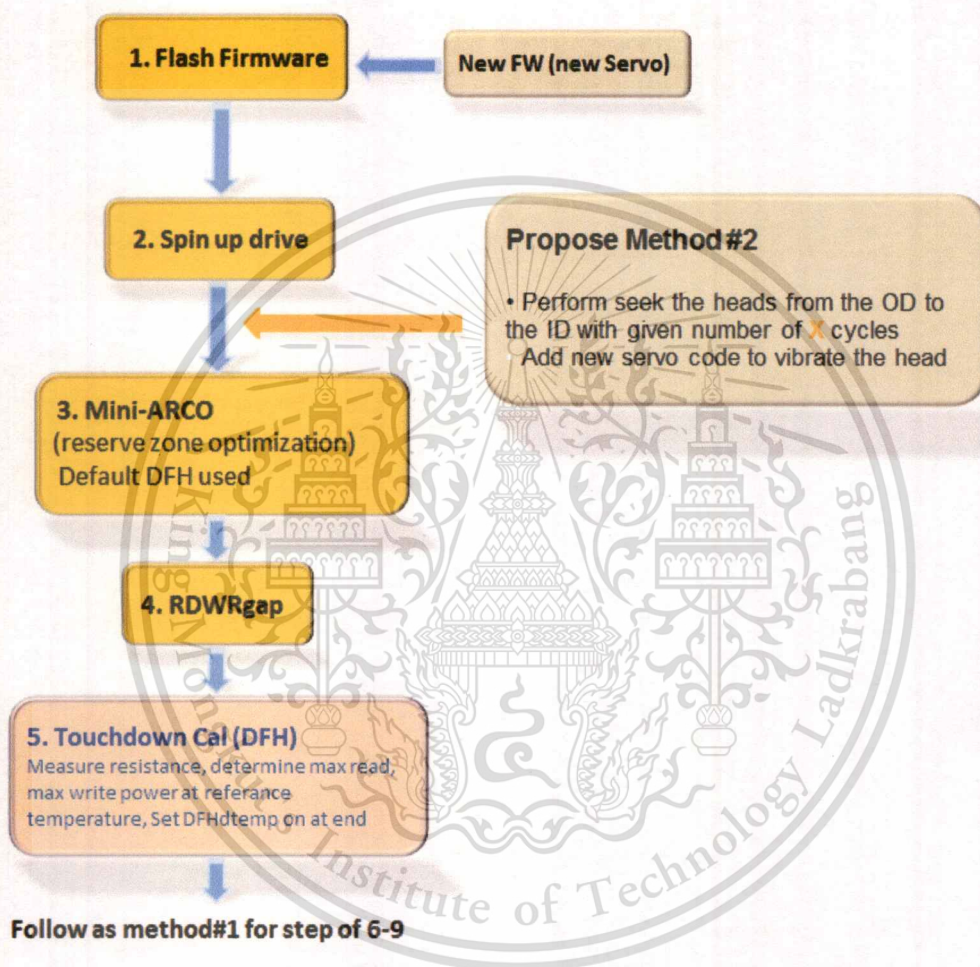
Fig 4.4 The optimal sequence and additional step of the second proposed method.

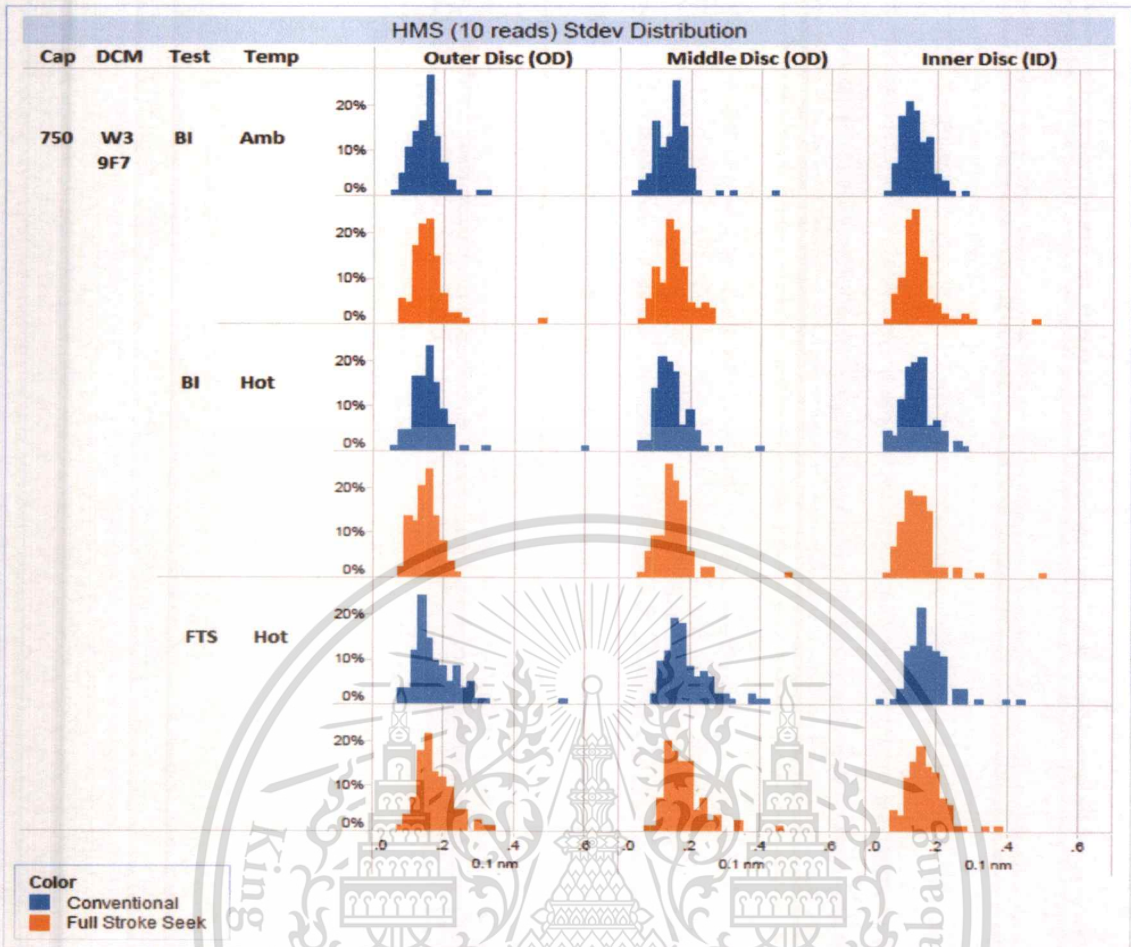
Fig. 5.10 Comparison of HMS between the current method and the proposed method.

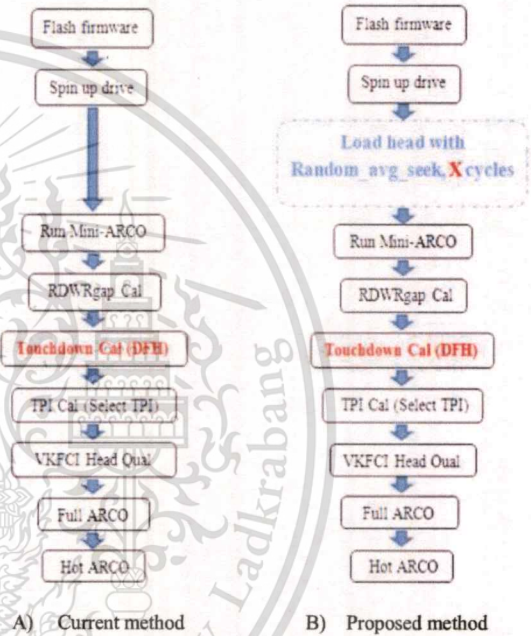
Fig.3. The Optimization Sequence of Touchdown Calibration and Flow chart of comparison between (a) current method and (b) proposed method.
