## รายงานสหกิจศึกษาฉบับสมบูรณ์

การศึกษาการสูญเสียผลผลิตในอุตสาหกรรมฮาร์ดดิสก์  
และ การปรับปรุงความสะอาดของเหรียญบรรจุหัวอ่านฮาร์ดดิสก์

**Cooperative Title:** Yield Loss Investigation and Slider Tray Cleanliness Improvement

**Company:** Seagate Technology (Thailand) Co., Ltd.

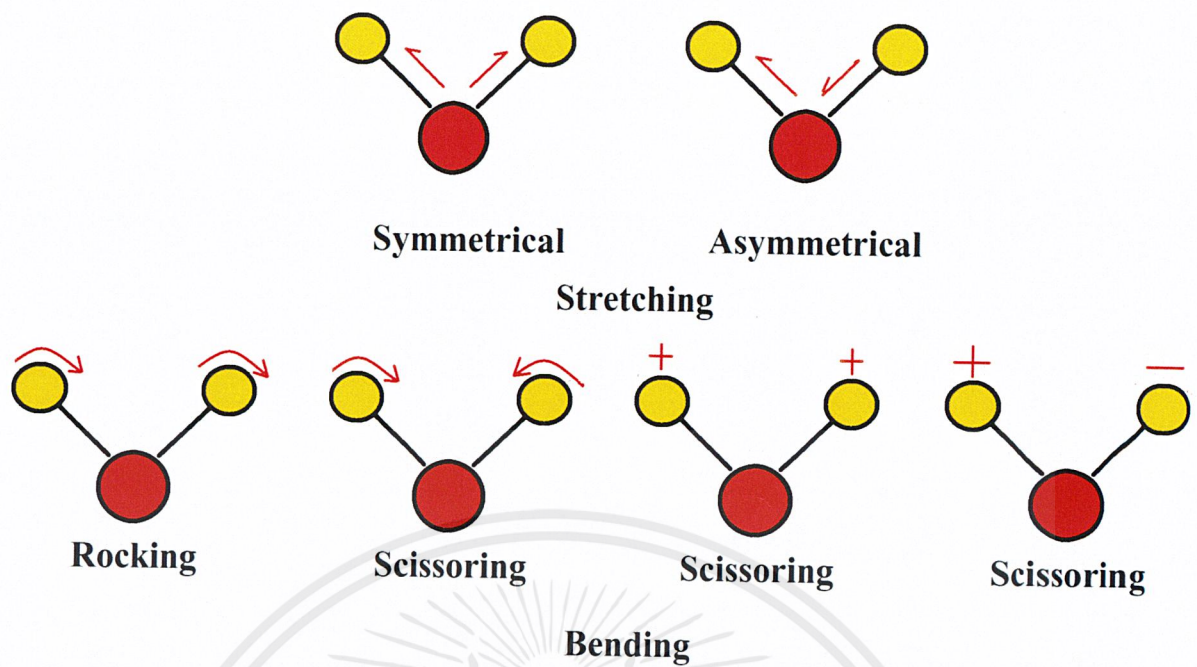
Figure 2.5 Examples of Molecule Vibration and Rotation Models. [6]

Infrared spectroscopy is a popular method that analyzes about molecular of material. It is the spectroscopic technique that uses infrared light and studies molecular interaction. It can give the functional groups with a sample. The bonds between the atoms vibrate and have two types of vibrational motions including Stretching and Bending. For stretching, the bond length would change. Stretching vibration has two types including Asymmetric and Symmetric vibration. Bending vibration is the vibration that leads to change a bond angle concerning the normal bond axis. For this vibration, one bond may rock back and forth within the plane it shares with another bond or bends back and forth outside that plane. Bending vibration have four types including Twisting, Rocking, Scissoring, and Wagging. In each of these vibrations would absorb different frequencies of the infrared. A photon of light which has a frequency in an infrared range will be absorbed if the bonds between atoms in the target sample allow these atoms to vibrate in this frequency.

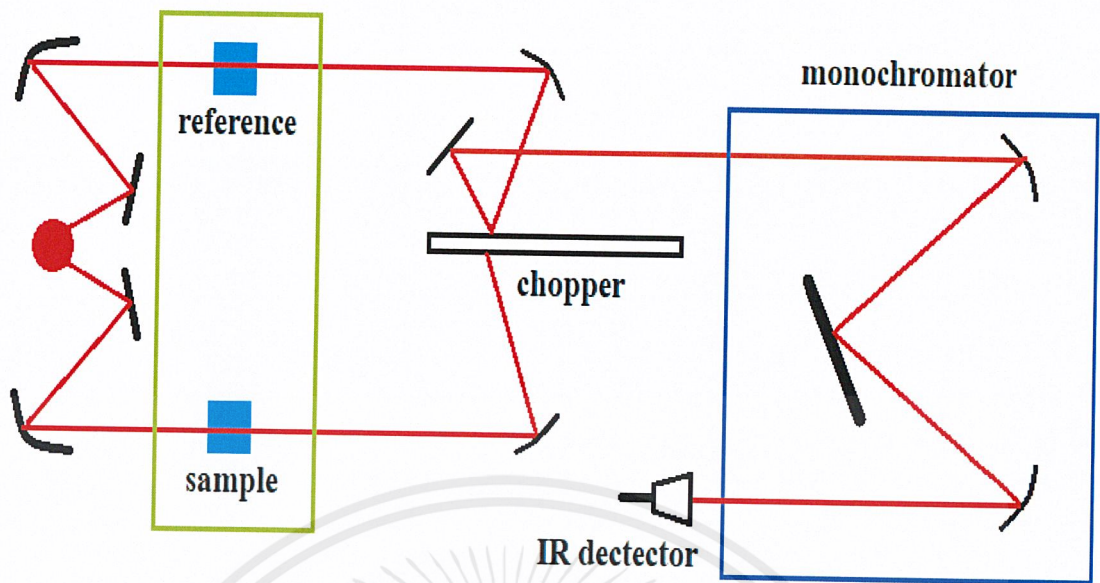
Figure 2.6 Infrared radiation spectroscopy instrumentation. [5]

The infrared instrument has a metal that heated to a high temperature at about 1500-3000K. The metal will emit the infrared radiation. Infrared radiation is allowed to separate from gratings. A chopper is located inside the instrument that chops the infrared radiation at regular intervals and separates them in two directions together. There two cells placed. First is a reference, and another is a sample. Therefore, chopper makes sure which the infrared radiation from the same source and same wavelength pass through both sample cells together. The chopper rotates about 10 rotation per second. Every molecule has a unique infrared radiation spectra, then infrared radiation spectra of any two molecules cannot be the same. For infrared radiation spectroscopy, the transmittance of the infrared radiation was checked. If there is any bond vibrating at the frequency that same as the infrared radiation, then the infrared radiation would be absorbed. Therefore, the transmittance would significantly decrease for that particular frequency. The result is shown the absorbance in the vertical axis and wave number of radiation in the horizontal axis.

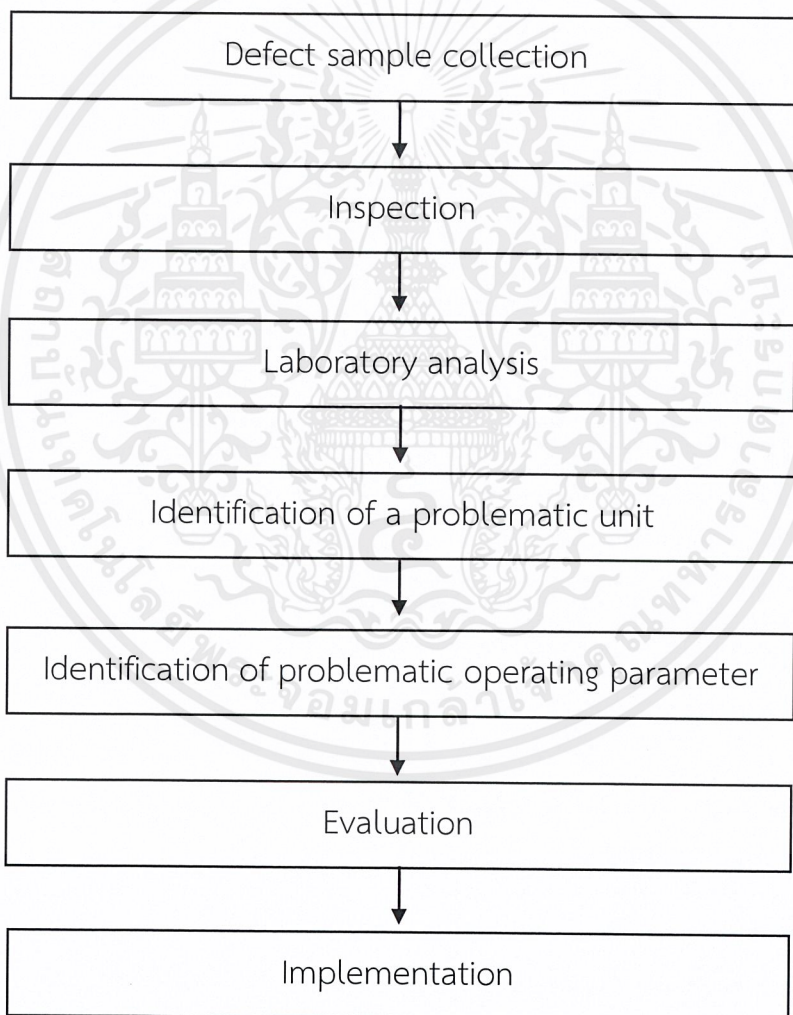
Figure.3.1 Experimental procedure

From objectives of this Co-Operation Education Project, first is to investigate a root cause of contamination yield loss in Seagate Korat plant. Next step is to decrease contamination yield loss for saving operation cost due to re-clean operation. Experimental flow diagram for yield loss investigation is shown in Figure 3.1. The first step is defect sample collection, follow by inspection, laboratory analysis, identification of a problematic unit, identification of problematic operating parameter, evaluation and implementation.

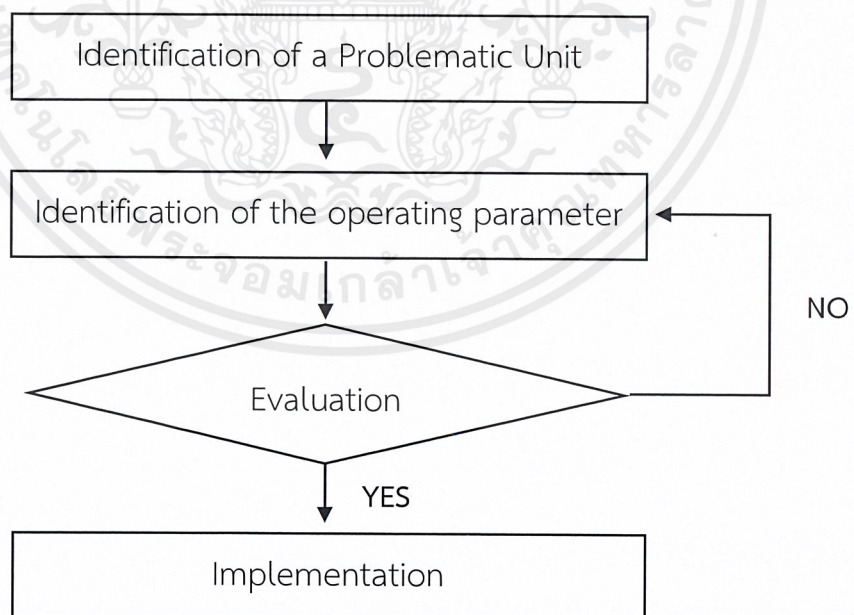
Figure.3.3 Re-evaluation step

After knowing the problem parameter, this step is an evaluation of this parameter to compare contamination yield loss with a control group. The results of the evaluation will ensure that this problem parameter is a root cause of the contamination problem. If this parameter ,not a root cause, then the new hypothesis will set, other parameters that are likely a root cause will be investigated and evaluated again until found a root cause of this contamination problem.

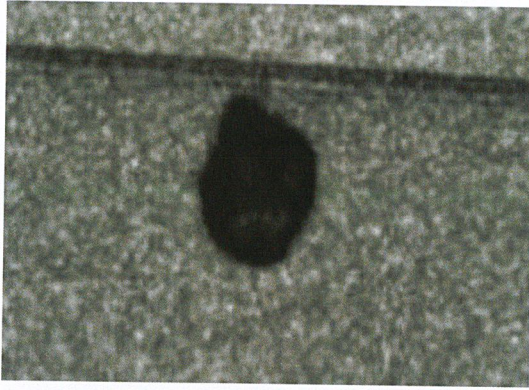
Figure 4.1 Type A contamination.

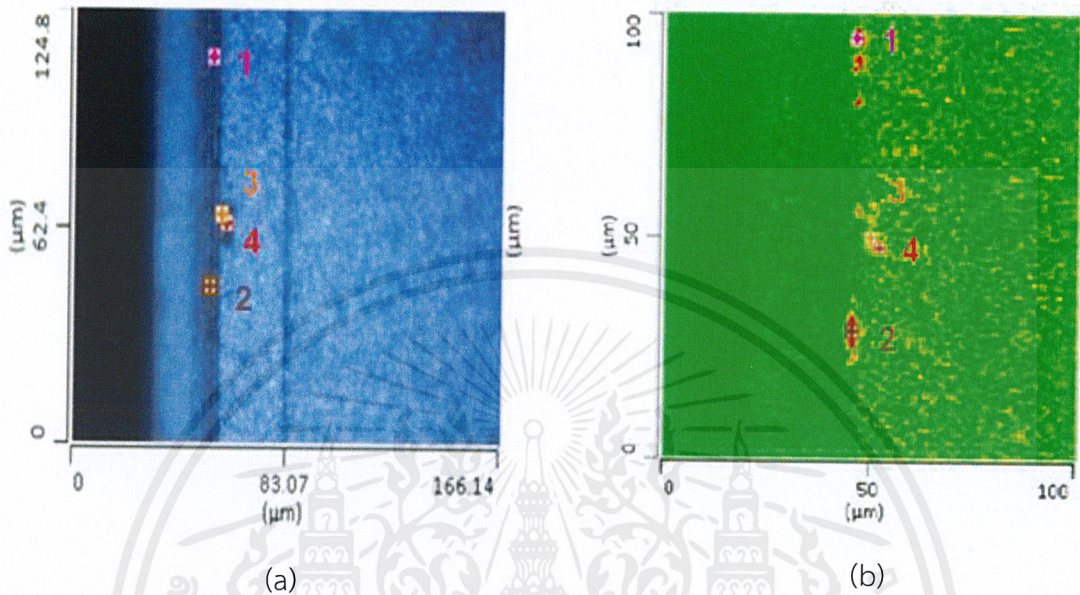
Figure 4.5 New type contamination defect sample image (a) the optical image (b) the optical photothermal infrared at  $1492\text{ cm}^{-1}$ .

This laboratory analysis determined four locations such as optically hidden defect site 1&2, defect site, and off defect. The spectra results show the both of optically hidden defect sites are the same trend chart but defect site and the off defect cannot detect spectra. Because of a defect site and off defect are too thin to detect spectra as shown in the optical photothermal infrared at  $1492\text{ cm}^{-1}$  in Figure 4.5b.

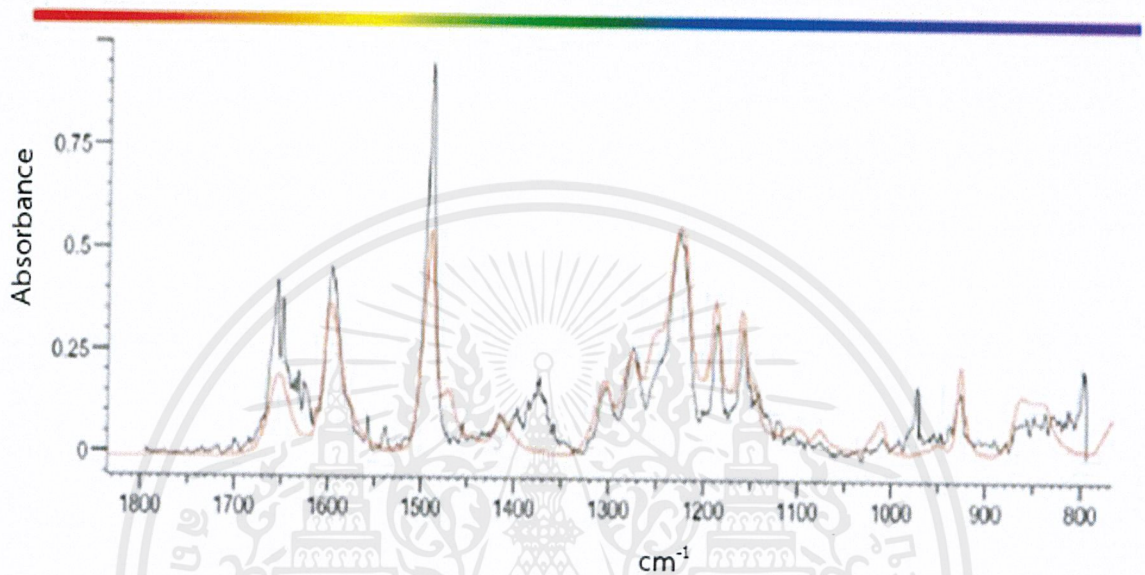
Figure 4.7 Infrared spectral of new type contamination matching with database.

Figure 4.7 shows good spectral matching of infrared spectral of new type contamination with the slider tray. The slider tray is specific equipment that used to pack up sliders in the cleaning process at slider section. Therefore, the section area of new type contamination problem was identified by this results.

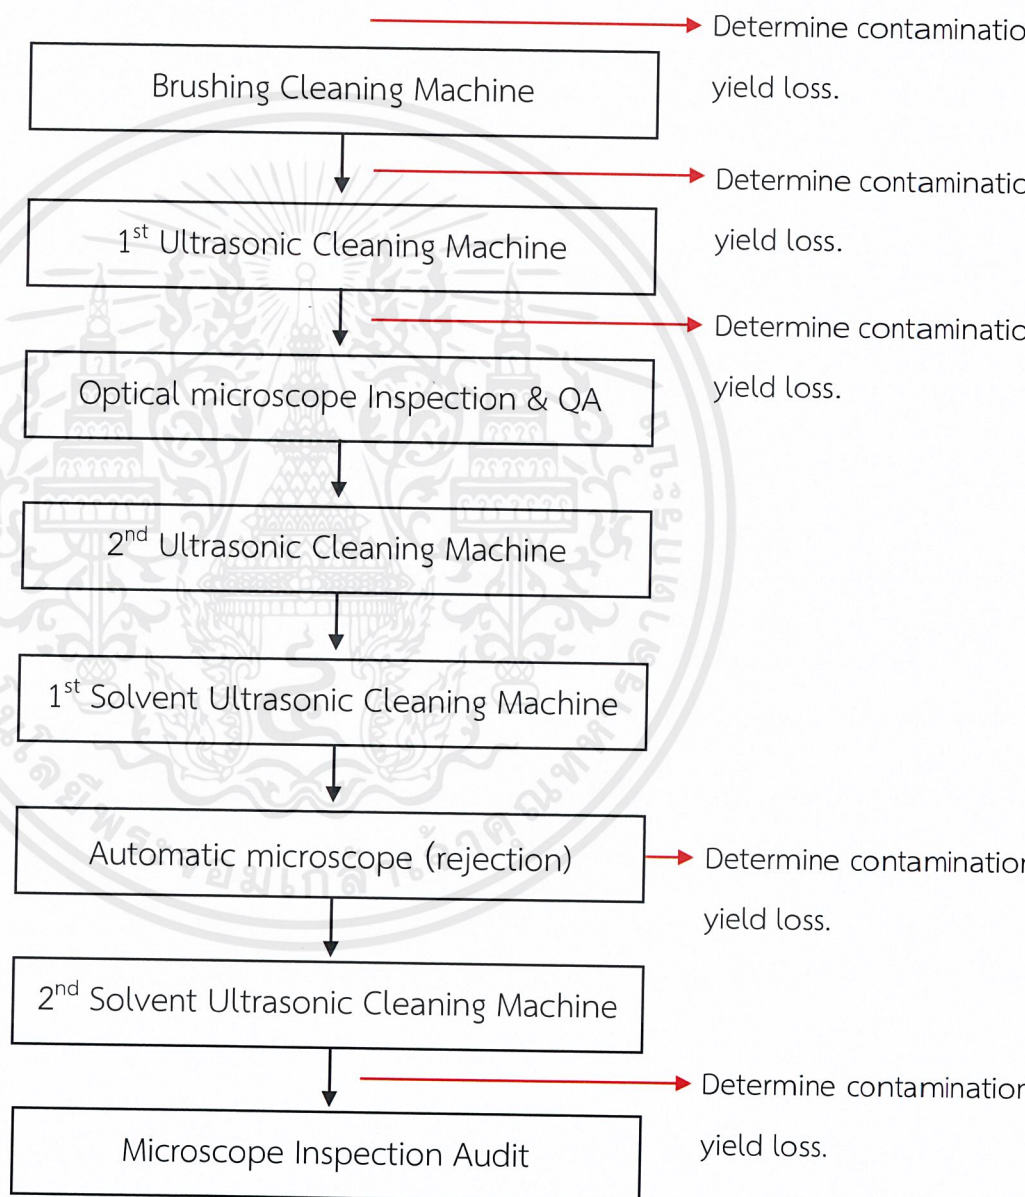
Figure 4.8 Cleaning process of slider section.

The cleaning process has three cleaning machine units including brushing cleaning machine, ultrasonic cleaning machine, and ultrasonic cleaning machine with solvent. Moreover, this section area has inspection units to check the cleanliness of slider product and reject a contaminated product. The cleaning process of the slider section was shown in Figure 4.8.

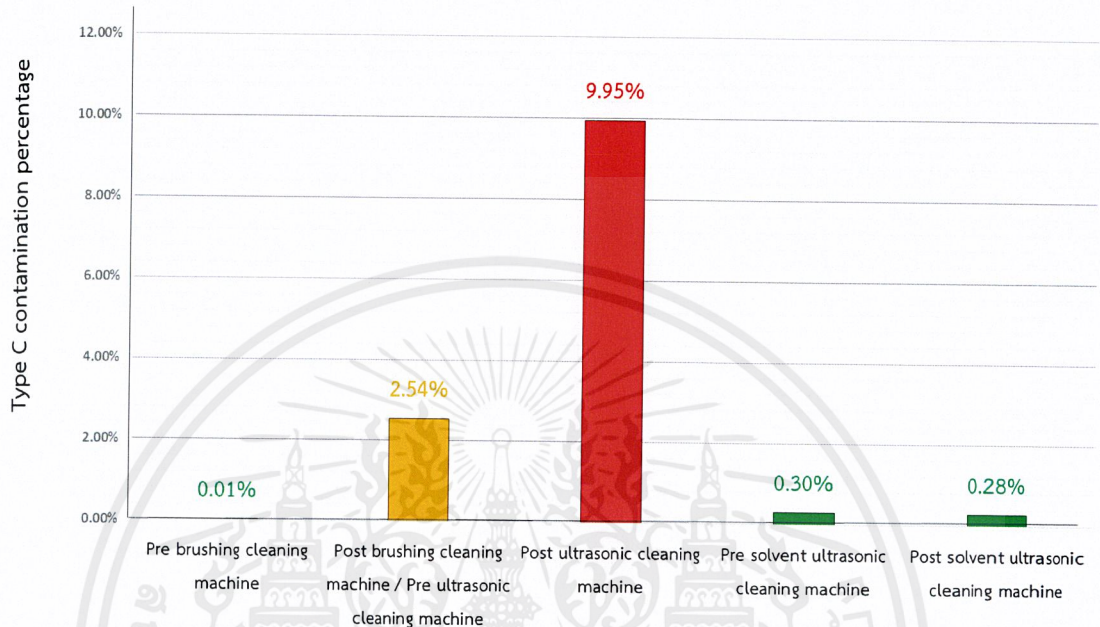
**Figure 4.9** Comparison of new type contamination yield loss in cleaning process.

The result show comparison of new type contamination yield loss between each unit in the cleaning process. The new type contamination increase after operates on brushing cleaning machine and greatly increase after operates on ultrasonic cleaning machine about 4 times. After 1<sup>st</sup> solvent ultrasonic cleaning machine, contamination percentage decreased to 0.30% because this machine uses chemical and sonication to effectively clean. But 0.30% is very high for the specification for only one type of contamination because other old types of contamination still occur. This problem increases an overall contamination yield loss to 0.80-0.90% from 0.5%. This result shows an ultrasonic cleaning machine is a problem unit of this contamination problem, so parameters of this unit machine will be investigated in the next step.

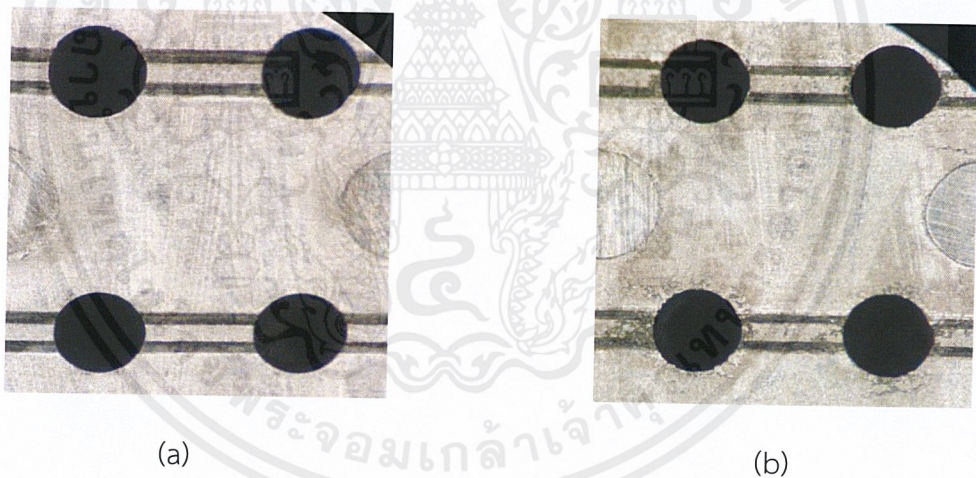
The first step of this investigation is the slider tray surface inspection by an optical microscope. Inspection results show that some trays surface are different from the normal tray as shown in Figure 4.11. It looks rough around a pore and likely to be frayed which may be a cause of this problem due to some material of tray be frayed out on slider surface and was heavily rubbed by a cover tray. Moreover, a rough surface increases a rubbing between a slider product and slider tray. It was called rough tray and other trays that do not have this surface problem, called smooth tray.

**Figure 4.11** Surface of tray by optical microscope (a) Smooth tray and (b) Rough tray.

From inspection, rough trays that tend to affect the cleanliness of the slider product. Then, a slider tray that used in the production line was sampled and separated to two groups including rough tray and smooth tray for liquid particle counting analysis. This analysis is used to measure the distribution and size of particles in a liquid or on a solid sample. The particle size is measured and the amount of particles present in each size

All of the results show that the tray cleanliness is one important variable that effects to increasing of contamination yield loss, so the tray cleanliness problem was solved first. The rough tray was separated from production line by year of production. From the investigation, almost all rough tray was produced in 2010, thus it can scan a tray barcode to be able to know a year of production and separate a rough tray from the production line. Seagate has ordered the new tray to replace the old tray that had a problem to prevent the shortage of slider trays. Moreover, every tray in production line was inspected by an optical microscope for making sure that a tray has no a surface or other problems before used. After these actions, the overall contamination yield loss was decreased from 0.9% to baseline that about 0.5%. But not only this action that decreased this contamination yield loss problem, there are other actions from other projects such as cleaning machine recipe improvement, and alternative flow improvement also.

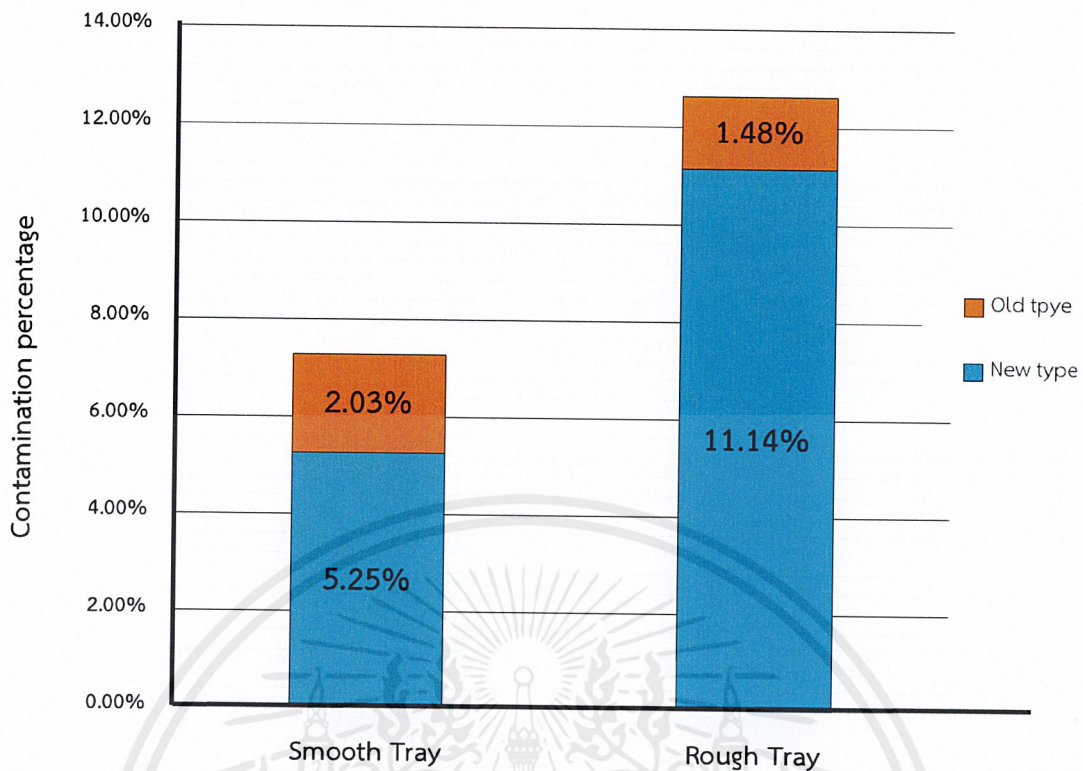
**Figure 4.12** The comparison of contamination yield loss between rough and smooth tray.

From Figure 4.12, the new type contamination is a majority contamination mode of both groups. For rough tray group, there is more new type contamination percentage than smooth tray group 2 times. If ignored a new type contamination, both groups are comparable. Therefore, the rough tray effected to increase contamination yield loss by increasing a new type contamination yield loss. Then, it is the reason that rough tray group has more overall contamination yield loss than smooth tray group about 5.34%.
